Jesusita Fire Watersheds

- Emergency Watershed Response Plan
- BAER Team Recommendations
- Bren School Recommendations
- USDA Forest Service Studies
- Jesusita Burn Area Mulch Area Development
- Similar Projects
 - Angora Fire, South Lake Tahoe
 - Gap Fire
- Quality of Mulch Materials

JESUSITA FIRE
Emergency Watershed Response Plan
Santa Barbara County Operational Area
Operations Section

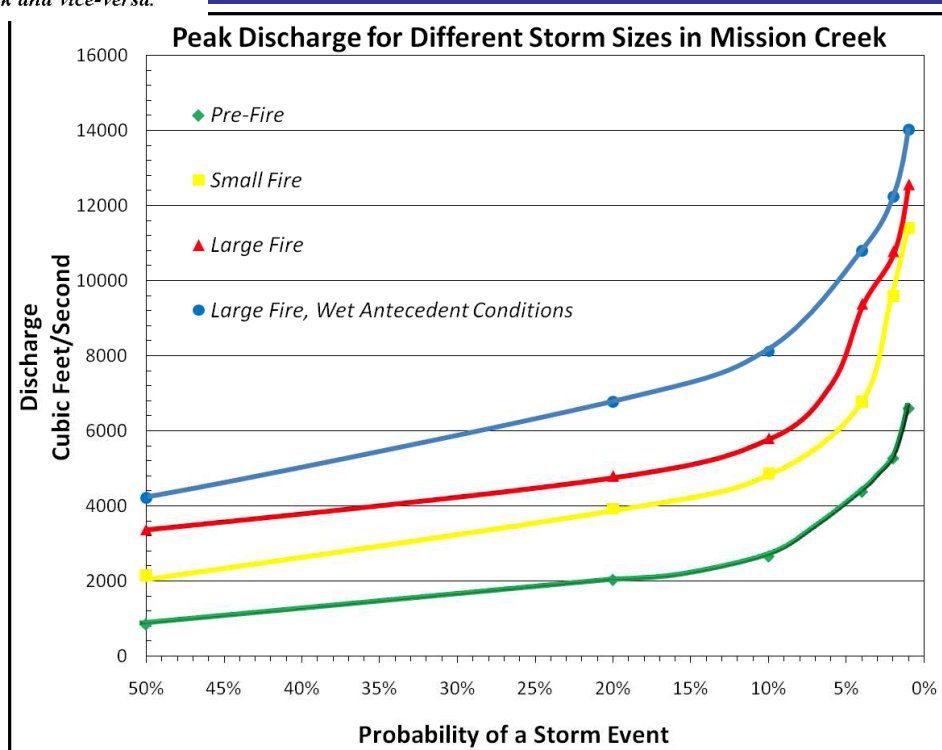
Figure 5-E: Predicted Peak Discharges at the Mission St. gauging station (USGS 11119750) for the 2-, 5-, 10-, 25-, 50-, and 100-year storms under four scenarios

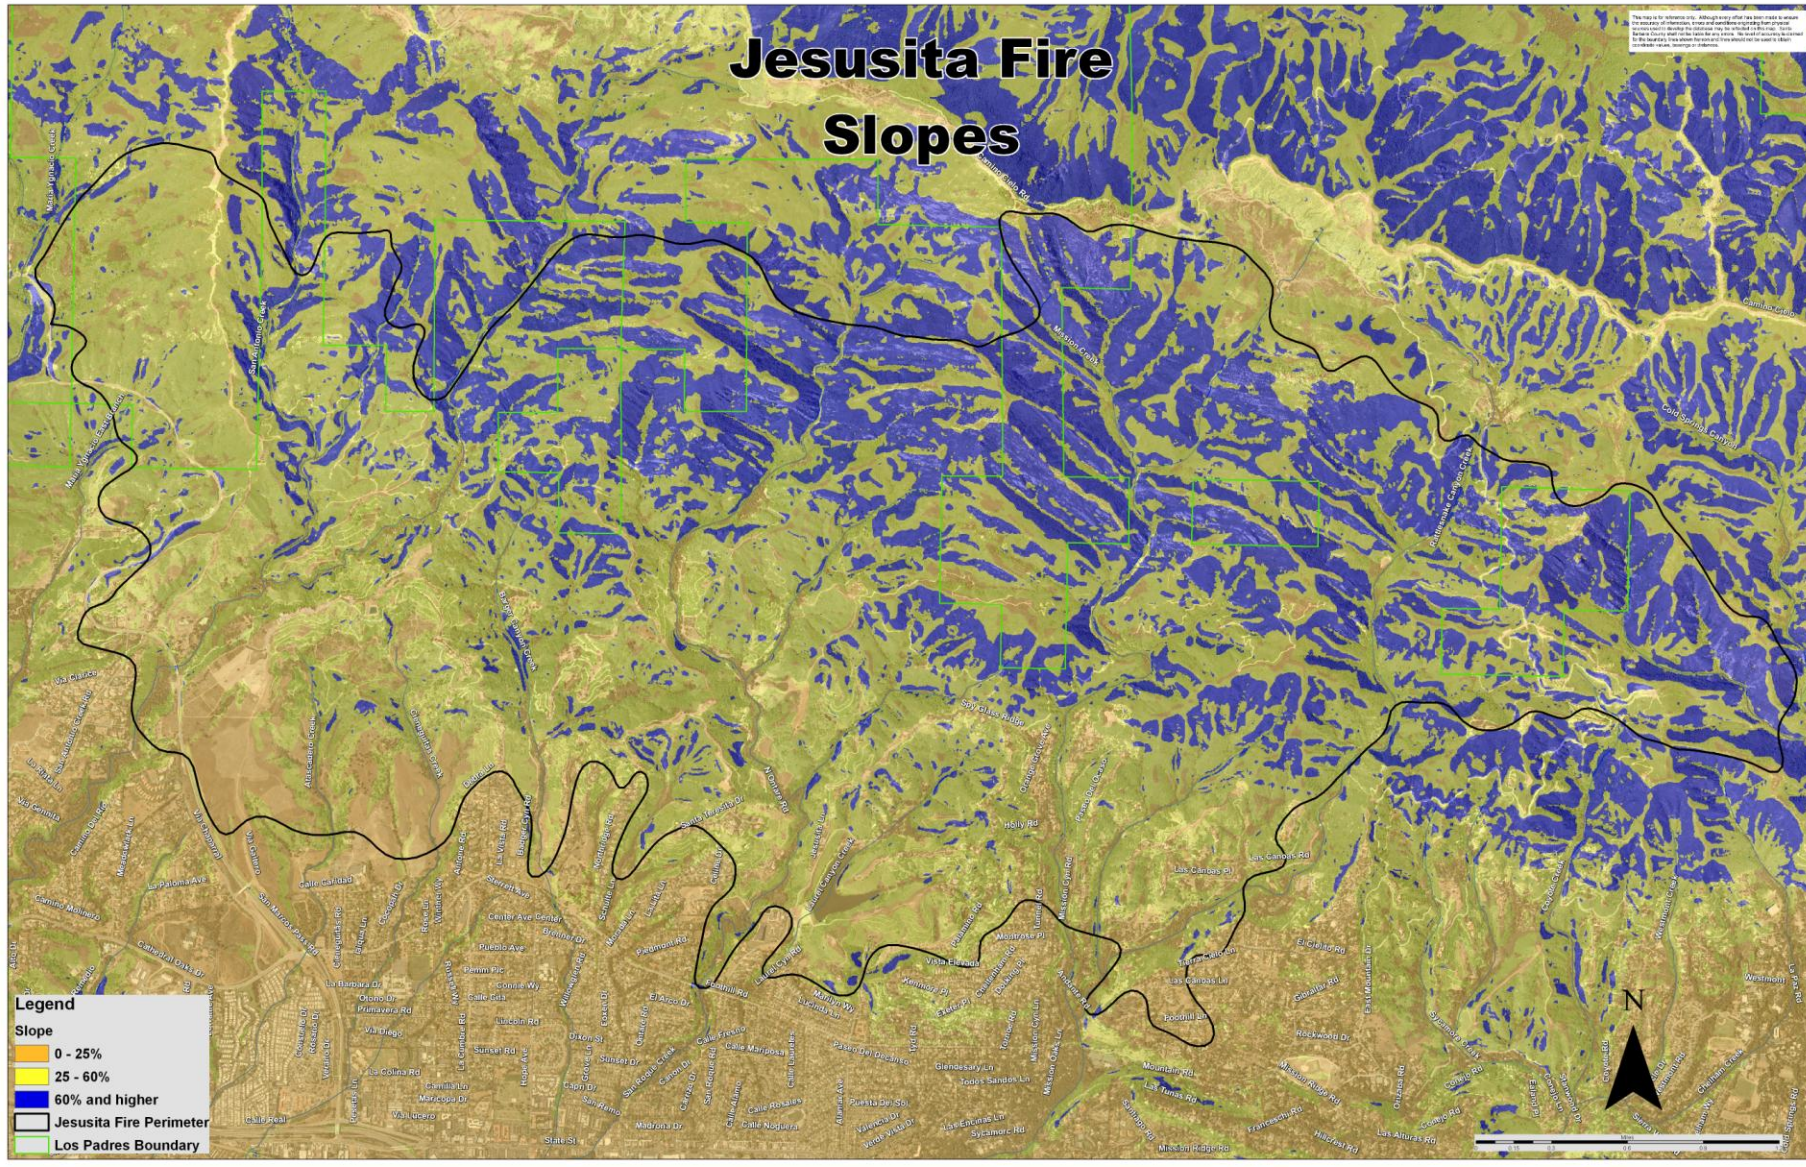
Jesusita Fire Slopes

Slope

- 0 - 25%
- 25 - 60%
- 60% and higher
- Jesusita Fire Perimeter
- Los Padres Boundary

Figure 2 delineates areas of moderate and high severity with slopes between 25% - 50%, and 50% - 60%. These areas represent potential treatable acres on National Forest and private lands, based on a GIS excersize. Actual treatable acres may be reduced due to rock outcrops, and other geographic features. Therefore, treatable acres need to verified on the ground.

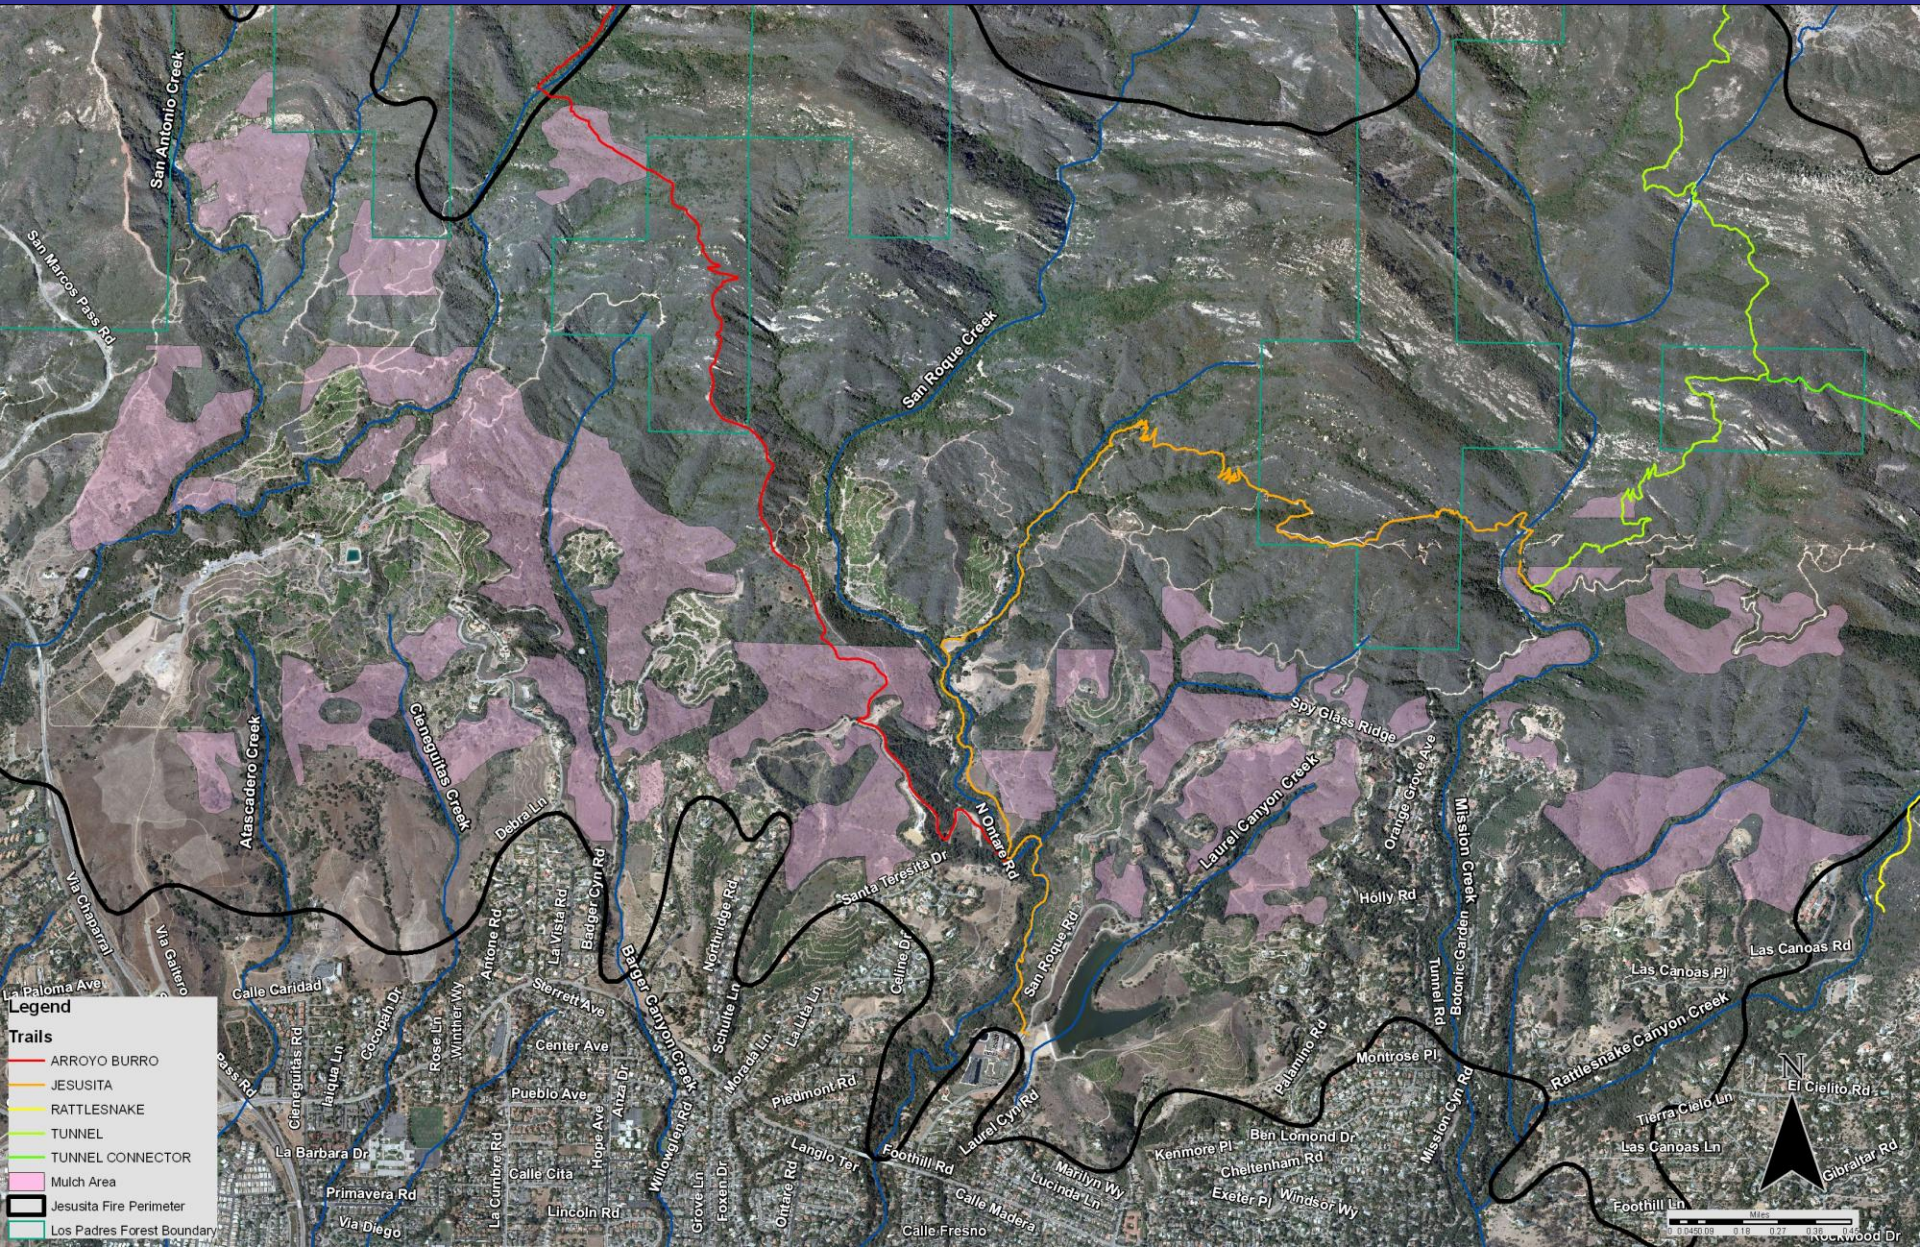
Mulch Areas (Draft) & Hiking Trails

- ARROYO BURRO
- JESUSITA
- RATTLESNAKE
- TUNNEL
- TUNNEL CONNECTOR
- Mulch Area
- Jesuita Fire Perimeter
- Los Padres Forest Boundary

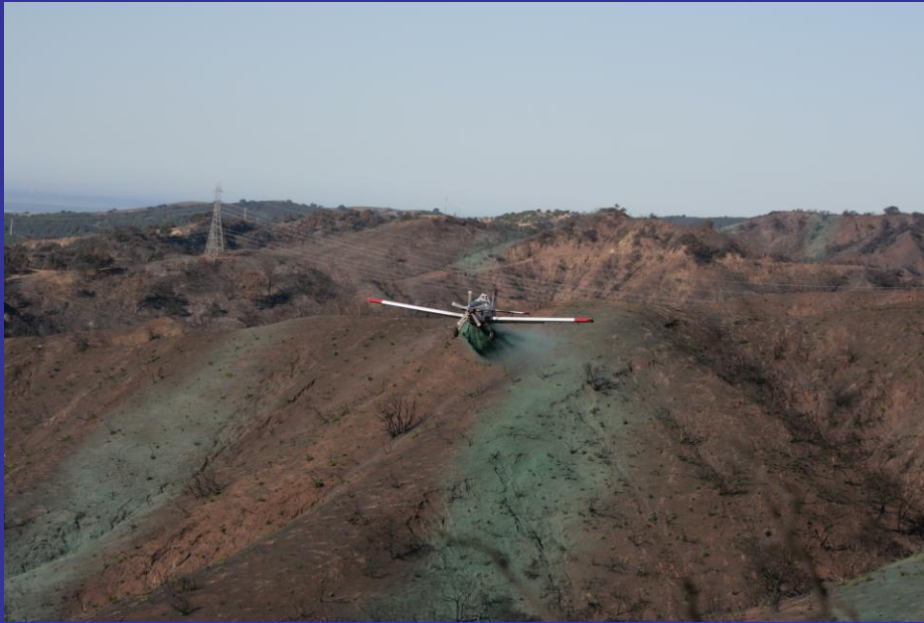
These aircraft are indispensable tools for applying hydromulch.
